# Manhole Inspection Summary

Manhole # S21C1\_020MH

Insp Date: **5/21/08 1:49 PM**

**Location** Address: **2639 paca st**

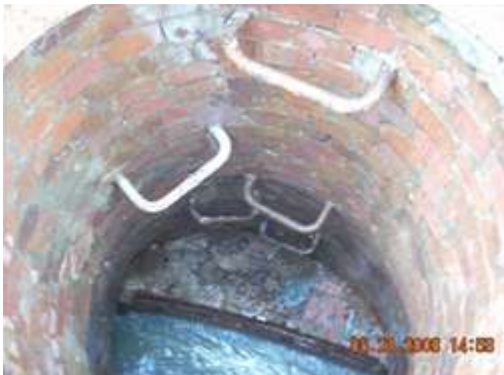
Defect 3

Count: **5** Missing: **0** ☒ Corroded

corroded steps

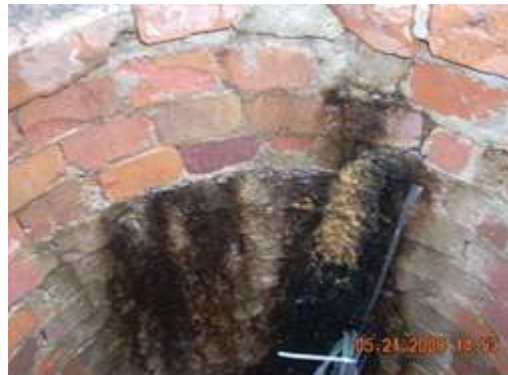
Defect 2

Infiltration: ☐ None ☐ Joint ☐ Cracks ☐ Mortar ☐ Roots ☒ Wall

infiltration @ corbel wall

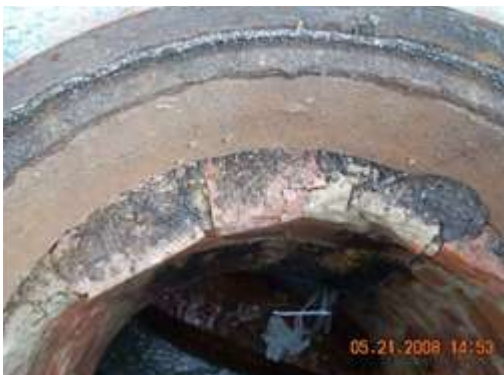
Defect 1

Offset: **3** (in.)

frame offset

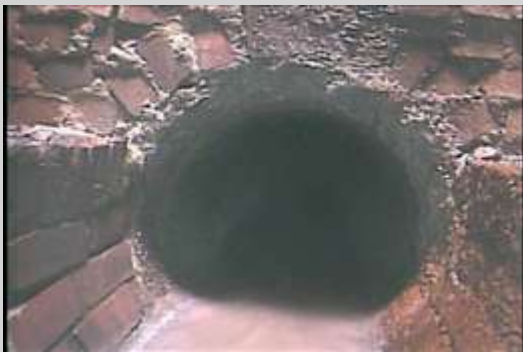
12 O'Clock Outflow

Pipe Height: **18** (in.) Rod and Bar (Angled)  
Pipe Material: **Clay** ☐ Pipe Lined  
Invert Depth: **9.29** (ft.) Flow Characteristics: **Slow**  
Deposits: ☐ None ☐ Mud ☐ Sludge ☐ Debris ☒ **Grease**  
Silt Depth: **2** (in.) Deposits Extent: **Light**  
Infiltration: **None** Pipe Seal Cond: **Sound**

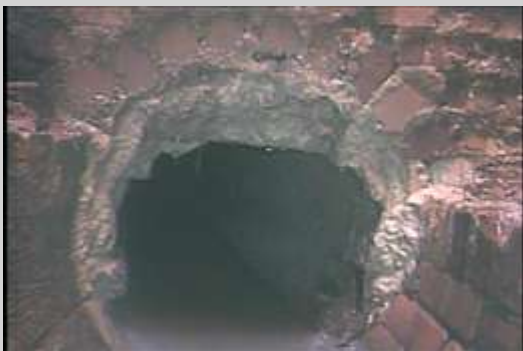
5 O'Clock Inflow

Pipe Height: **18** (in.) Rod and Bar (Angled)  
Pipe Material: **Clay** ☐ Pipe Lined  
Invert Depth: **9.22** (ft.) Flow Characteristics: **Slow**  
Deposits: ☐ None ☐ Mud ☐ Sludge ☐ Debris ☒ **Grease**  
Silt Depth: **4** (in.) Deposits Extent: **Medium**  
Infiltration: **None** Pipe Seal Cond: **Sound**
